A PICTORIAL STUDY OF

# SEISMIC DAMAGE

AND THE USE OF  
PROPER SAFEGUARDS.

SD-100

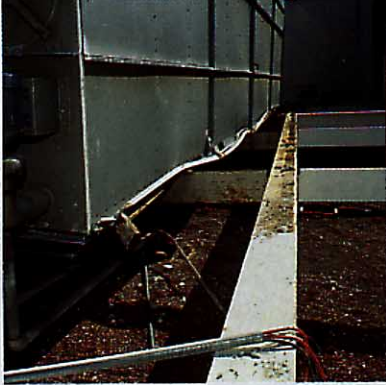
*The independent rails rotated around their longitudinal axis, snapping anchor bolts and bending the cooling tower base. The problem could have been prevented by using a one piece structural base and double acting snubbers.*

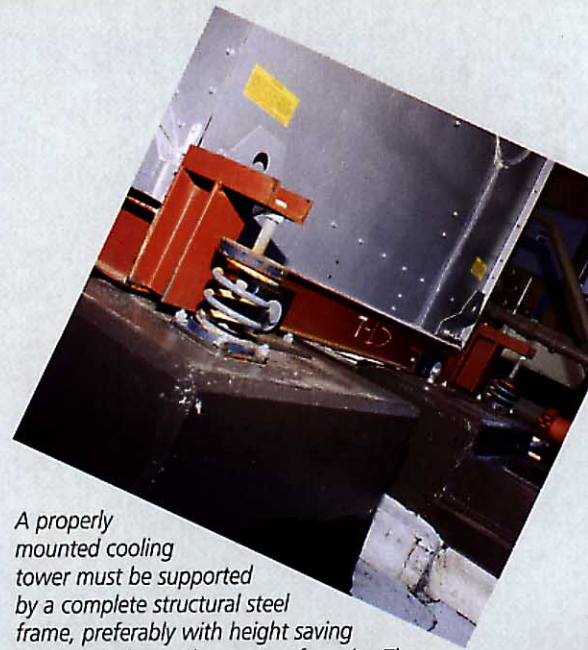
*A properly mounted cooling tower must be supported by a complete structural steel frame, preferably with height saving brackets to lower the center of gravity. The free standing spring mountings need not be bolted down, as the blue all directional seismic snubbers next to each spring, limit the spring's motion. These all directional seismic snubbers are shown in Chapter 49 of the 1991 ASHRAE Guide Application Manual. Snubbers are double acting and selected for maximum calculated forces. Springs should be positioned within holders rather than welded to avoid cracking. Adequate edge distance to snubber anchor bolts is extremely important (Mason WF Base, SLF Spring Mountings, Z-1225 Snubbers).*

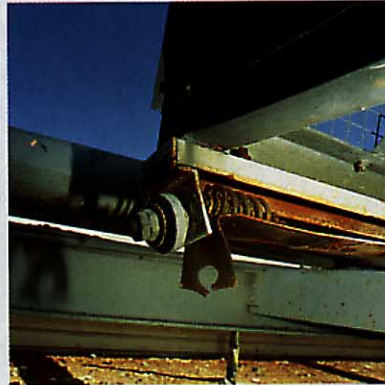
*The vertical snubber bolt could not prevent the rail rotation. The anchor bolt tore through the base plate and the support springs fell over.*

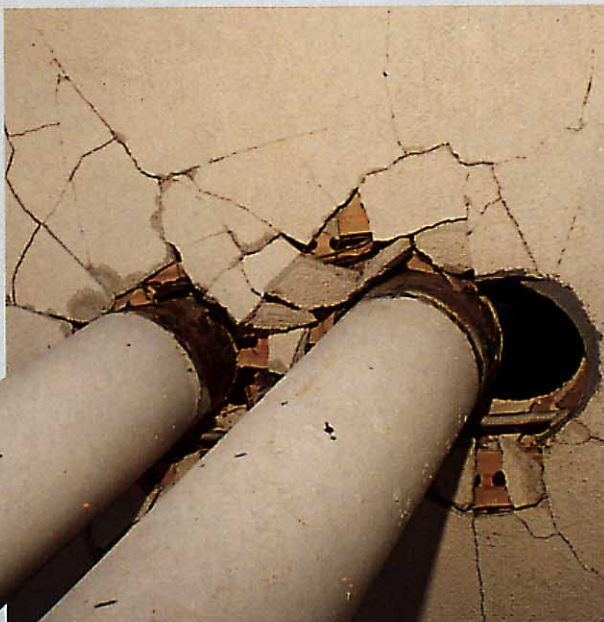
*Improperly restrained piping can damage the structure itself. Unlike duct work, piping has mass and rigidity. Electrical lines in walls can be destroyed when piping shifts. Columns can be distorted and the structural integrity of bearing walls can be compromised as well.*

*This damage was caused by the relatively minor forces of 0.15gV and 0.2gH.*

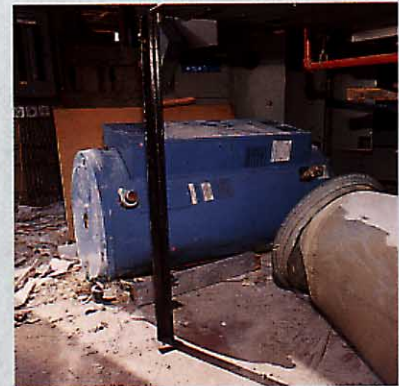
*Water heaters have high centers of gravity and tend to turn over easily. The forces on this particular installation were 0.15gV and 0.2gH, heaters should be bolted to the floor and strapped to the nearest wall or column.*

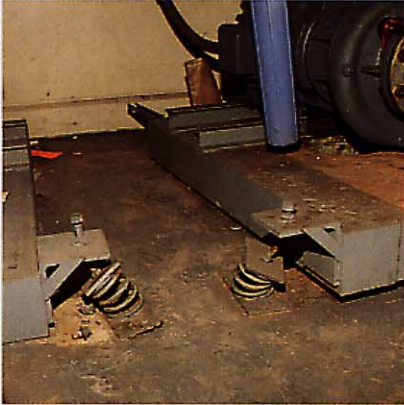
*This is an excellent installation using all directional seismic snubbers to prevent the concrete bases going into resonance as would happen if the springs were used alone. There is no reason to bolt the springs to the floor as the snubbers restrict motion and the springs do not shift on their friction pads. Snubbers must always be anchored with proper anchor bolts. (Mason BMK Bases, SLF Spring Mountings, Z-1225 Snubbers)*

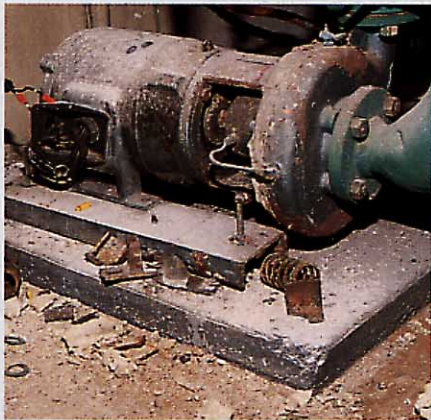
*Gray cast iron spring housings invariably shatter as shown. The shrapnel flies in areas that may be occupied by plant room personnel. The only acceptable castings are ductile iron or cast steel.*

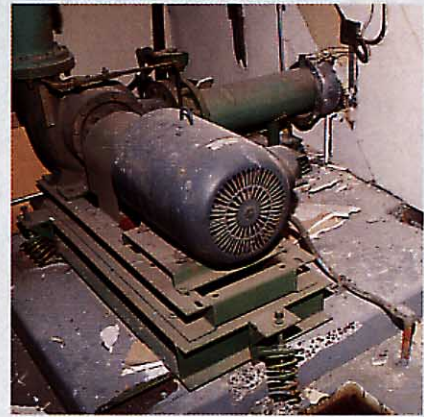
*Another example showing free standing springs cannot be used without snubbing devices. The anchor bolts under these spring mountings were too close to the edge, and broke the housekeeping pad. Forces were relatively low at 0.2gV and 0.25gH, but more than sufficient to create havoc on this unsnubbed, resonant system.*

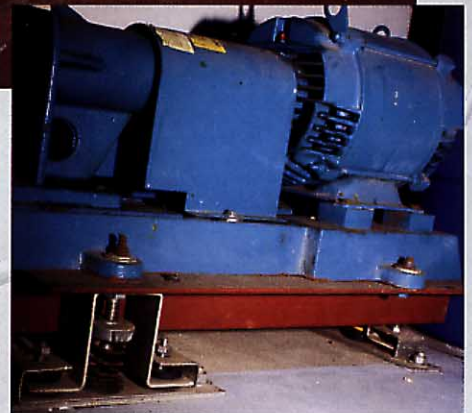
*This pump system is mounted on a steel frame to minimize floor loading. The springs are inside a steel seismic housing with all directional elastomeric grommets to prevent hard surface impact. Anchor bolt edge distance was more than adequate and the system showed no sign of failure. (Mason MSL Base, SLRA Spring Mountings with extended base plates)*

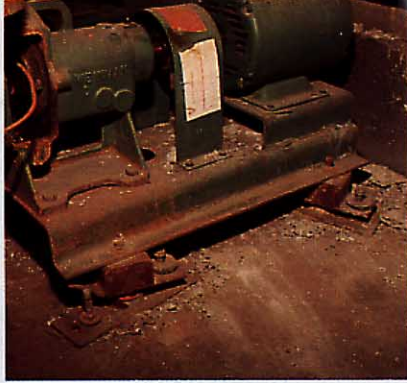
Mounting a pump directly on mountings without a supplementary steel or concrete base is bad practice because of pump coupling alignment problems when torque twists the bases. The mounting housings proved inadequate as the vertical restraining bolts failed. The restraining angles bent and either the anchor bolts were sized inadequately, of the wrong type or poorly installed as the anchorage broke free and the pump shifted out of position. Input was a low 0.2gV and 0.25gH.

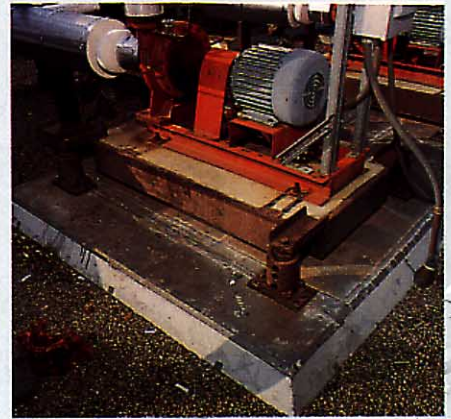
Shatter resistant ductile iron housings are the correct choice in seismic areas. Inputs were very high at approximately 1.5gV and 1.4gH. The systems did not fail because the entire load path was properly designed. Notice that the anchor bolts are widely separated and edge distances are very conservative. Both the floating concrete base and the housekeeping pad were properly reinforced and the housekeeping pad securely attached to the structure. (Mason BMK Base and SSLFH Ductile Spring Mountings)

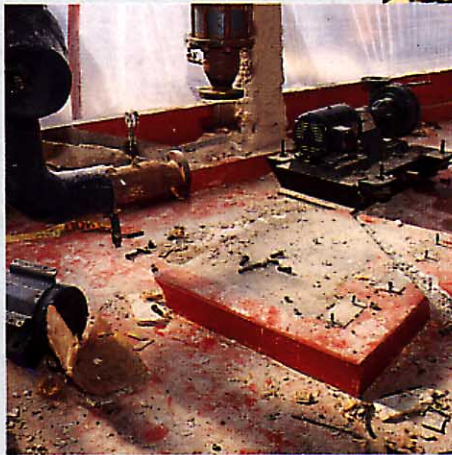
Housekeeping pad failures were common, because of improper doweling or fastening to the structural floor, and inadequate or no reinforcement in the pad itself. These pads, as the pads on the cover, had both problems. Inadequate fastening allows the pads to lift, chatter and shift. Poor reinforcement allows breakage. When the pads fail, the system must fail as nothing remains in place.

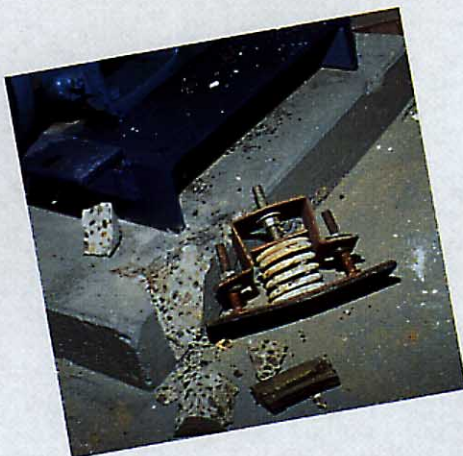
The anchor bolts were too close to the edge of the concrete housekeeping pad for the concrete to offer adequate resistance to the horizontal anchor bolt forces. The edges broke off so the anchor bolts were freed. This total failure of the restraint system occurred at only 0.15gV and 0.15gH. The mountings themselves showed considerable distortion as well.

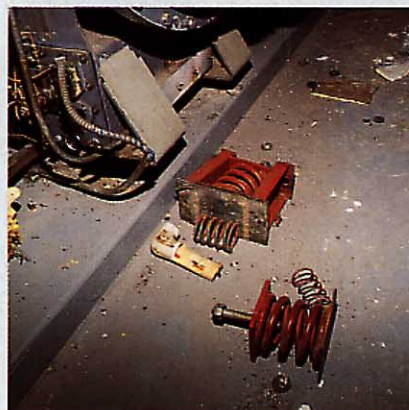
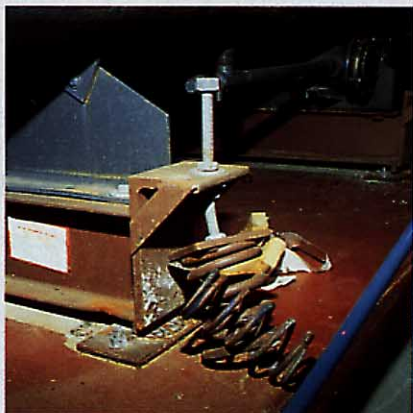
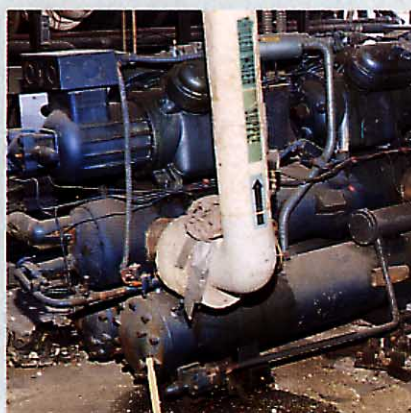
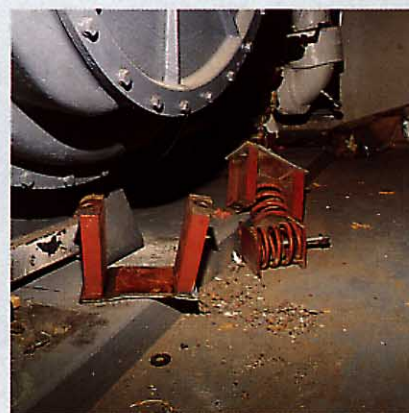
Rails rotated in virtually every application. In the upper photograph the rotation was initiated by the horizontal snubber pushing against the web of the beam. In both photographs the springs were secured by welding. Welding is always poor practice as the intense heat embrittles the spring so it tends to snap at the weld and scale inclusions produce welds that pop off. All systems failed with pipe breakage in addition to the other problems.

Another example of gray iron mounting failure. Fragments shown in the lower left and lower righthand corners can be dangerous to building personnel as well as equipment. Not only is the compressor out of service, but there is the additional worry of potential liability and damage.

Some chillers can be directly mounted on spring isolators, but not as shown in photographs above. Seismic forces were reasonably high at 0.3gV and 0.6gH. Not all the parts are shown in the photographs, but both the restraining bolts between the upper and lower housings and the anchor bolts failed. The top plates came free of the rest of the housing and may still be attached to the chiller. Base plates were weak and showed distortion. Mountings rated by test with OSHPD pre-approval would have been far safer. The chiller dropped some 14" in addition to shifting.

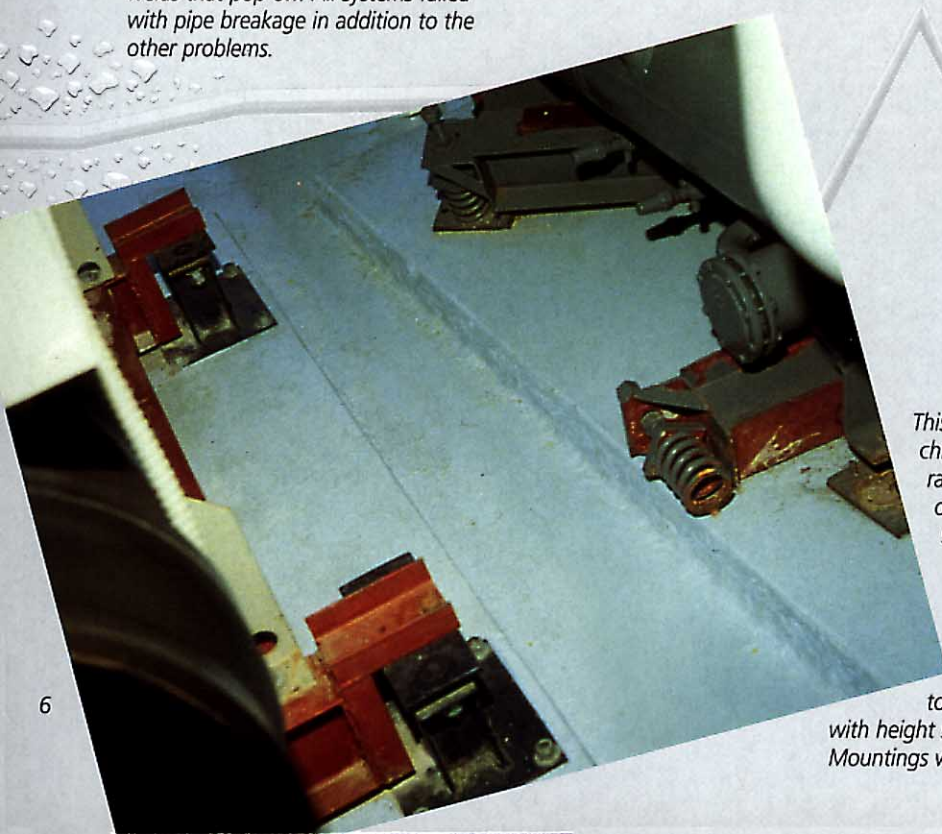
This unusual photograph shows identical chillers side by side. One was mounted on rails with snubbers bearing against the webs of the beams. The other on a one piece structural steel frame supported by spring isolators with seismic restraints built into the steel housings. The base plates were enlarged to insure proper anchor bolt spacing. The rail installation failed completely, but there was no damage to the steel base system. (Mason WF Base with height saving brackets and SSLR Restrained Spring Mountings with enlarged base plates for anchorage.)

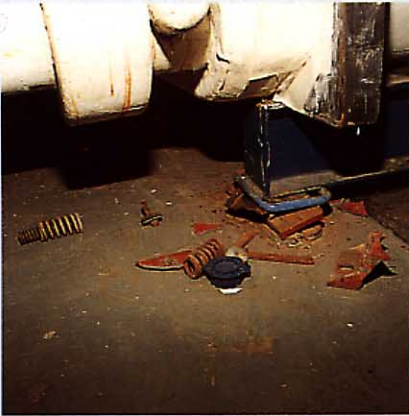
This photograph is a close up of the spring and all directional snubber installation below. The anchor bolts and the clearances from the edge of the housekeeping pad were all carefully calculated. (Mason WF Base, SLF Springs, Z-1011 Snubbers)

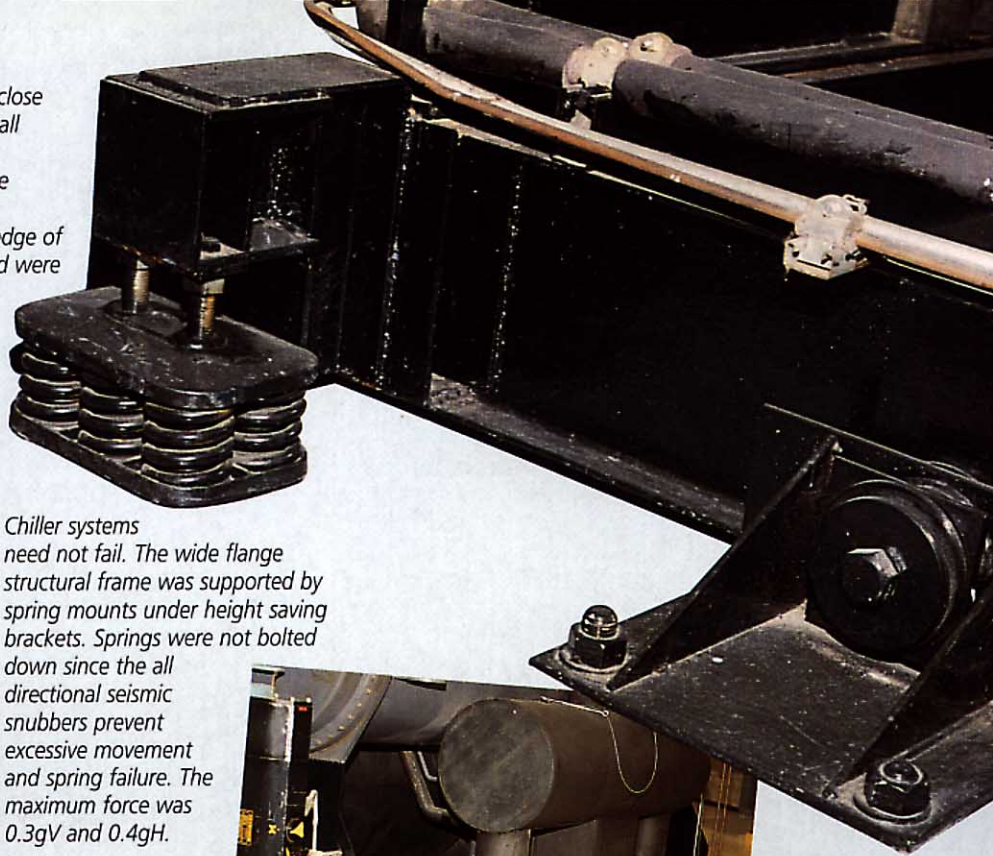
Chiller systems need not fail. The wide flange structural frame was supported by spring mounts under height saving brackets. Springs were not bolted down since the all directional seismic snubbers prevent excessive movement and spring failure. The maximum force was 0.3gV and 0.4gH.

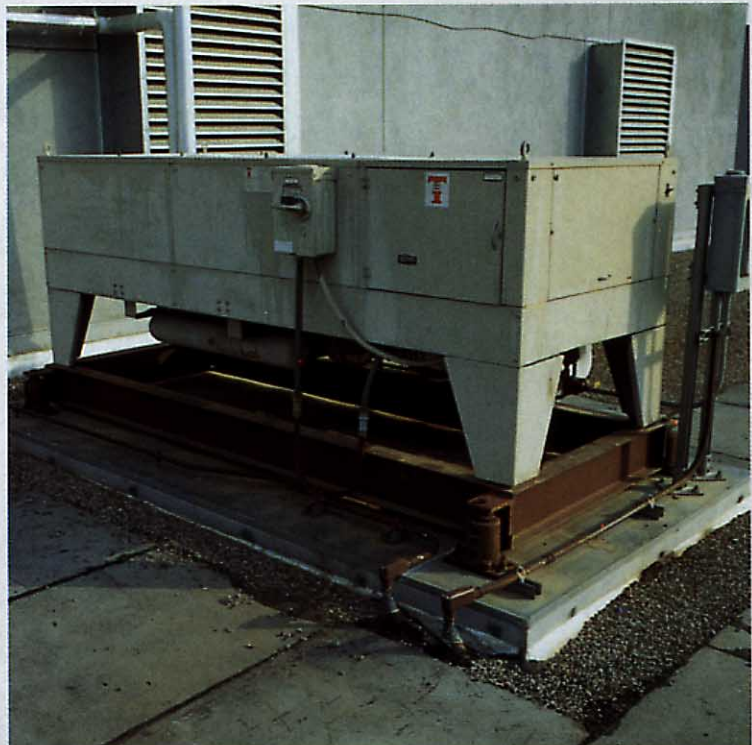
This is an excellent installation using a structural steel frame with height saving brackets and spring mounts with their own built in seismic protection. These are not malleable or gray iron, but ductile castings that will not shatter. The air cooled chiller has very light sheet metal legs which did not buckle, because the steel frame tied the four legs together. This unit was almost at the epicenter of the earthquake and saw seismic inputs of 1.0gV and 1.4gH. These are some of the highest forces ever recorded by an instrument anywhere in the world, but the installation survived intact. (Mason WF Base, SSLFH Snubbed Spring Mountings)

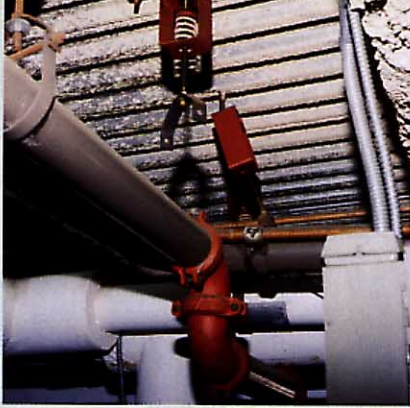
The clevis hanger in the center of the photograph fell apart and the rear hanger clevis is sufficiently displaced to have bent the ceiling bolt. There are chatter marks on the pipe in the front clevis, all indicating that this system went into resonance even though the accelerations were only 0.15gV and 0.2gH. Proper sway bracing, axial restraint and upper limit stops could have prevented this damage.

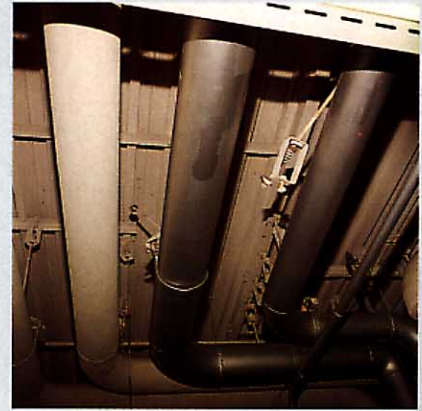
Piping without sway braces will shift position and change elevation. One hanger broke completely free and one pipe is displaced approximately 12" from its original location. On other jobsites, piping systems came down. Sway bracing and axial restraint is essential along with vertical limit stops at anchorage locations. Clevis bolts must be sleeved or braced as well.

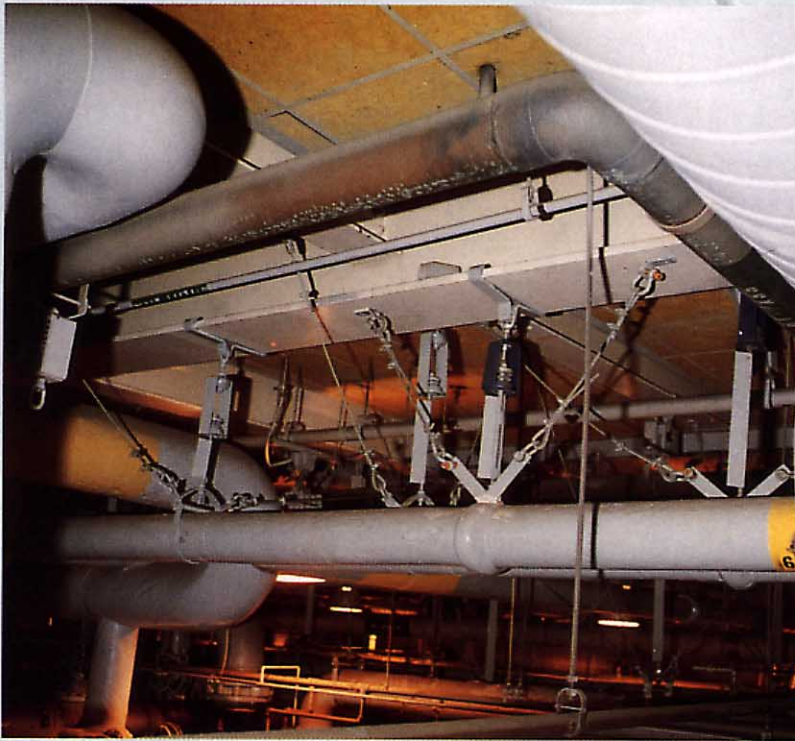
Piping with cable sway bracing survives an earthquake with no damage and no distortion. Forces in this area were high at 0.9gV and 1.2gH.

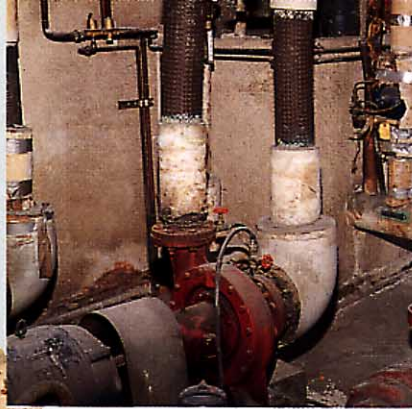
Even with this extreme displacement of the flexible connector, the expensive cast iron gate valve was protected. This teflon connector was distorted beyond the manufacturer's movement limitations. A double sphere rubber joint would have had a much better chance of survival and it would only have been necessary to properly reposition the piping. (Recommendation: Mason Safelex SFDEI)

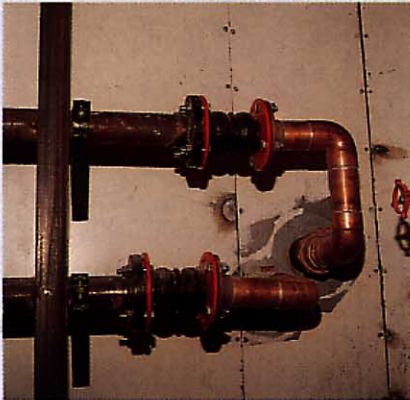
Metal flexible hose is designed to accept motion at right angles to the axis. The hoses prevented pump body failures, but after the system was back on line, the hoses leaked. Leakage was caused by metal fatigue, over travel transverse to the axis or compression and extension. Double sphere rubber connectors are all directional and can respond to motion in any direction without failure. (Recommendation: Mason Safelex SFDEI)

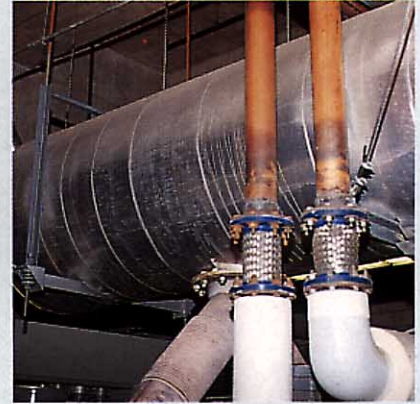
The metal flexible hose prevented pipe failure. However, the metal hose on the right was compressed. Braided metal hoses cannot accept compression and it had to be replaced. Flexible metal joints do not have the same movement capabilities as rubber joints, and tend to fail under seismic conditions. The seismic input was 0.15gV and 0.2gH. (Recommendation: Mason Safelex SFDEI)

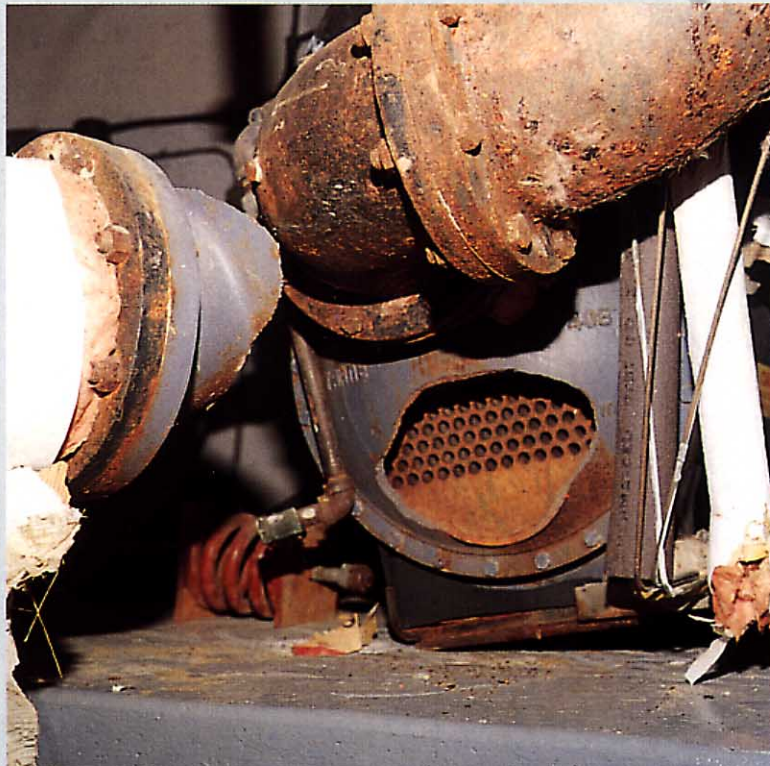
An excellent example of equipment failure at the piping interface. Both the restrained equipment and piping move out of phase during an earthquake and the cast shells are not designed to accept the force necessary to drag the piping. Cast component failures are common. The solution is installation of a spherical twin sphere rubber expansion joint to allow for the motion.

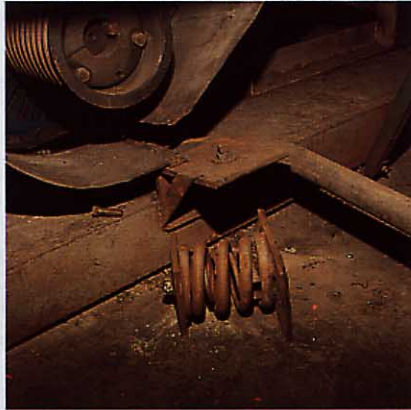
*This close up of the spring shows that the attachment bolt broke allowing the spring to shift and fly free. (The spring was moved back for the photograph.) This would be a dangerous missile anywhere, but particularly in an equipment room with electrical devices. Proper snubbing would have controlled the situation.*

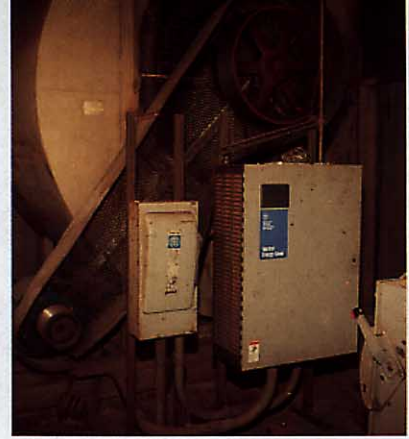
*Spring isolators must be used with seismic snubbers to prevent resonance at seismic frequencies.*

*When the horizontal amplitude became excessive, the whole system shifted releasing the springs while still compressed to 1,500 lb. This sudden release of energy can do damage to anything in the path of the flying springs. Unsnubbed systems not only fail, but they can be dangerous even at low input figures of 0.15gV and 0.12gH.*

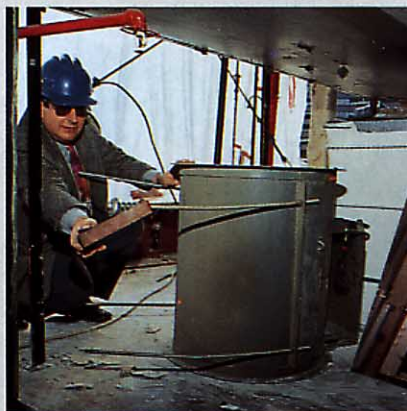
*This small tubular fan broke free of the ceiling and landed on the mechanical room floor. It could have caused severe injury or equipment damage. Electrical lines and control panels are particularly sensitive. This swinging almost always takes place when seismic energy is applied to suspended systems. Proper cable sway bracing would have limited the pendulum action.*

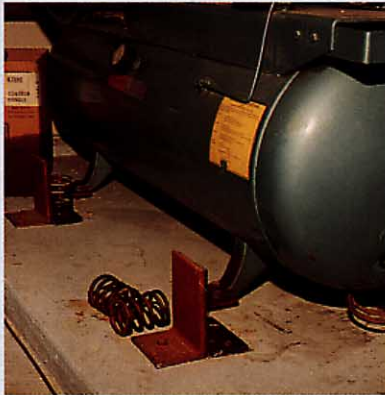
*The spring mountings under this air compressor failed, because the snubbers were not all directional. Single bolted restraints can rotate. This angle had a simple pad cemented to one face. The arrangement could only contain the system transversely rather than in all directions. As is typical, the equipment resonated and the springs fell over. Forces were about 0.25g Vertical and 0.35g Horizontal. Proper all directional snubbers would have solved the problem.*

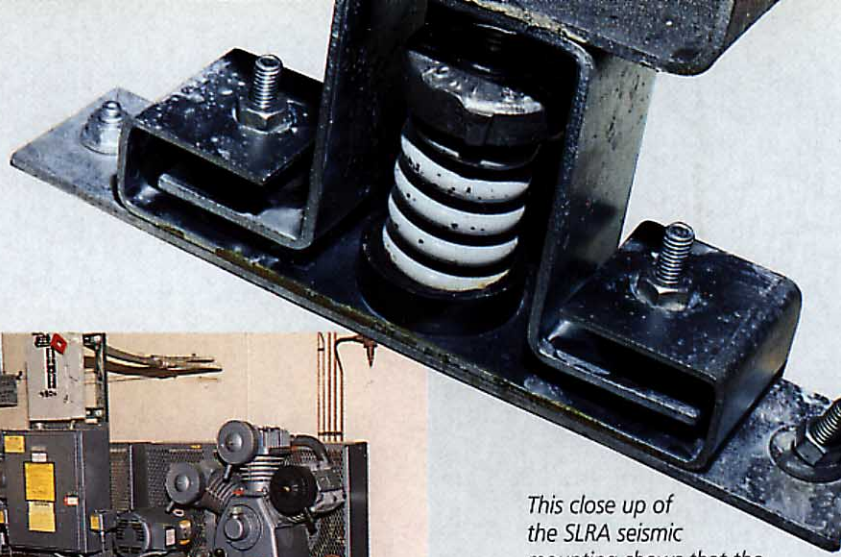
*This close up of the SLRA seismic mounting shows that the righthand anchor bolt was distorted at installation and not by the quake. Were it a seismic shift, the other bolt would have been bent as well. The all directional Neoprene collars reduce the impact of steel on steel. (Mason SLRA with extended base plate for anchorage)*

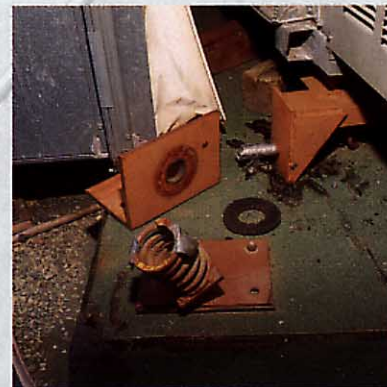
*Using a poor copy of a good snubber can result in disaster. Rather than a snubber made with a one-piece double acting, all directional Neoprene sleeve with washer faces, this hard rubber washer was cemented to the angle. The rubber bushing does not appear to be thick enough. The minor cost saving, if any, resulted in a dramatic, costly failure and major equipment displacement.*

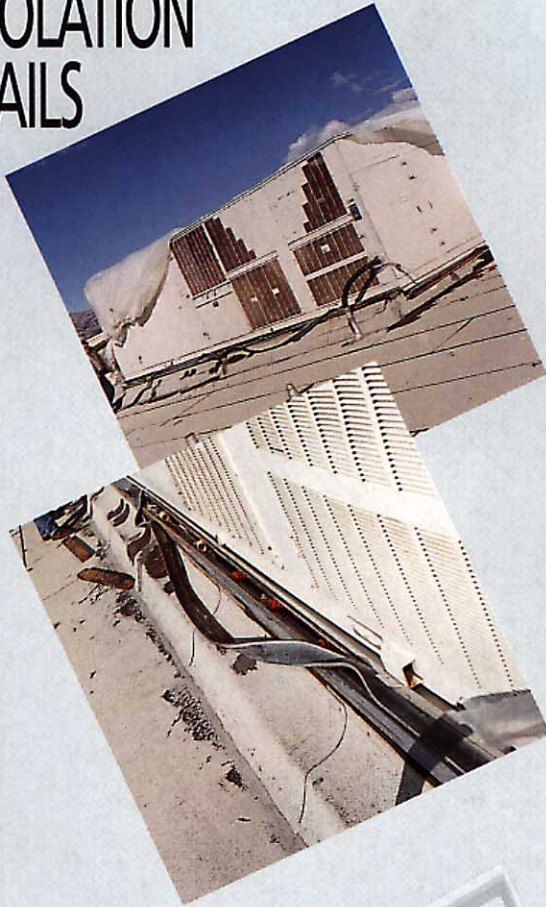
Curb top aluminum isolation bases have very little structural capability and generally fail. These failures are difficult to repair as the roof seldom allows for rigging, and the unit has to be lifted by helicopter or crane before bases can be replaced. Forces were small at 0.1gV and 0.15gH. The problem could have been prevented by using a seismically OSHPD approved complete isolation curb for the same application.

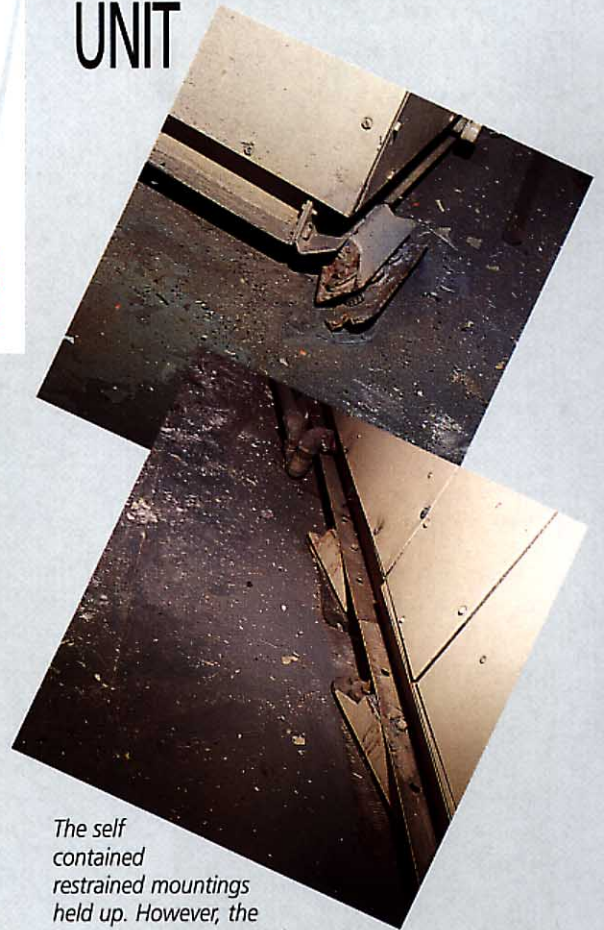
The self contained restrained mountings held up. However, the formed channel base deformed badly and the mounting anchors let go. All of the isolators either rotated or shifted. Part of this problem was the use of slots in the base plates rather than holes. Slotted holes simplify installation, but they are single acting and minor shifts allow one end to escape the anchor bolts and the other to follow. The system would have survived had it been mounted on a steel frame with adequate anchor bolts through base plate holes. Forces were not high at 0.15gV and 0.2gH.

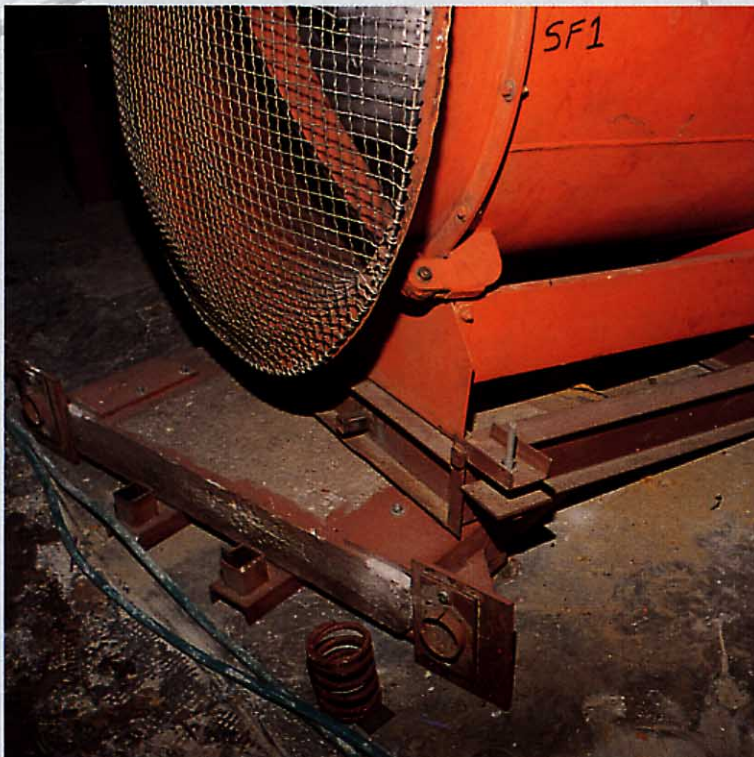
This axial fan was mounted on two concrete piers. The piers fell over sideways because of inadequate anchorage to the structural floor and the axial fan fell about 3 feet. This could have been prevented by pouring the piers with a concrete web between them. The entire load path should always be studied from the structural slab right up to and including the equipment mountings. Forces were 0.2gV and 0.25gH.

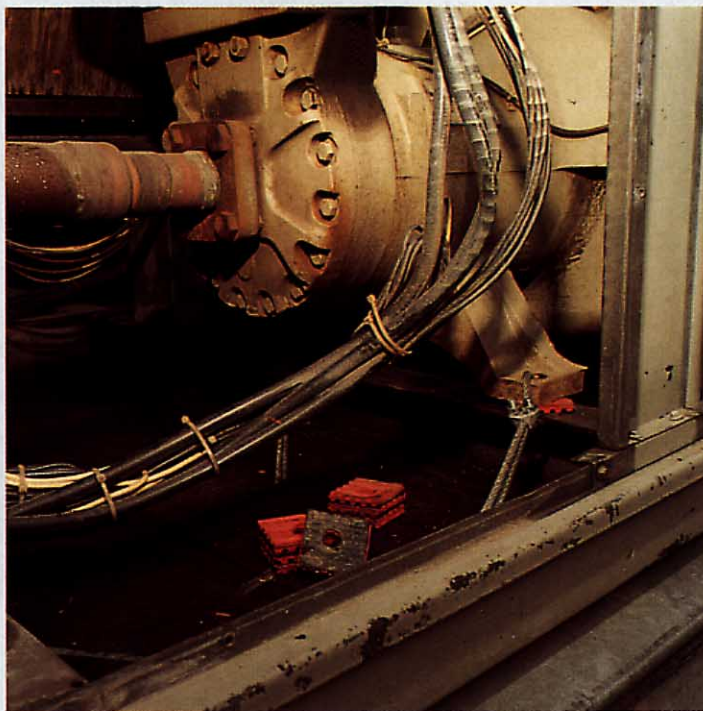
The cable system is an emergency measure to try to keep the compressor in place in anticipation of after shock. Forces were small at approximately 0.15gV and 0.2gH. Equipment with hard mounted internal components and external cushioned seismic isolation systems have a better chance of remaining operative.

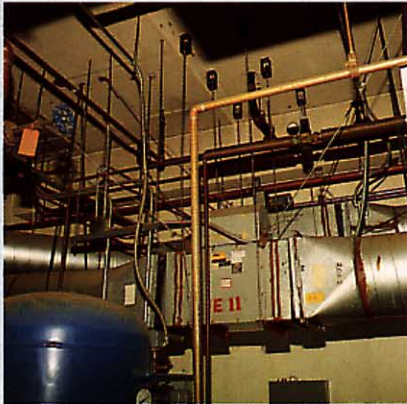
The roof mounted ducts were supported by the steel columns. The four columns were not interconnected, because the loading was so light. However, horizontal forces were large enough to cause failure as the supports were not cross braced to form one integral unit.

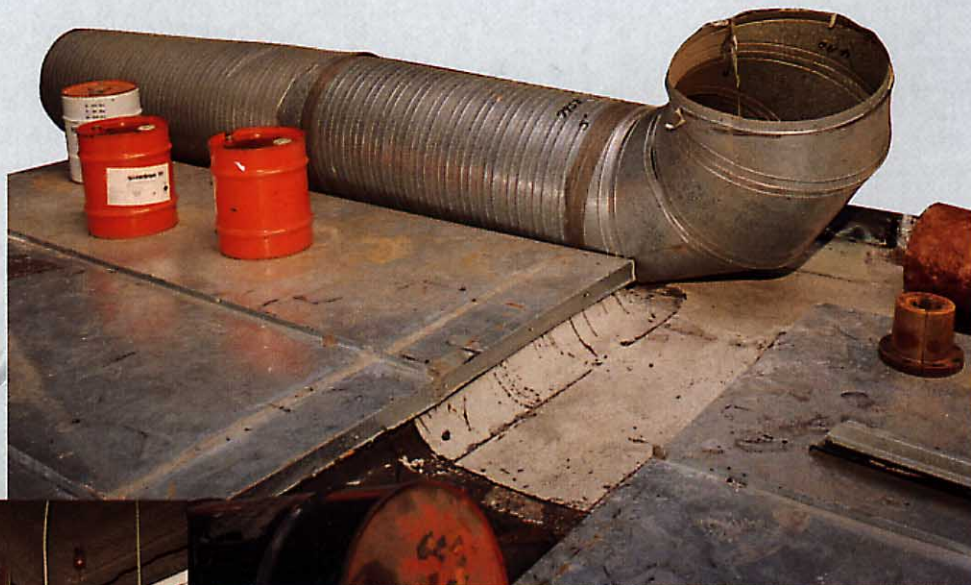
Duct work is very susceptible to seismic damage. Notice the straps that held the ducting that is now on the floor shown in Photograph to the left. This can be prevented by the use of sway bracing to limit sway and keep the duct work in place. Input was 0.15gV and 0.2gH.

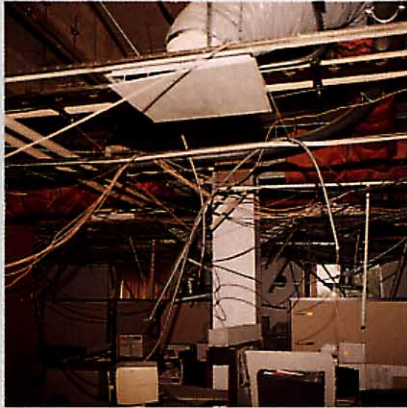
*Suspended ceilings sustained damage in many installations, because sway wires were not used at all or installed improperly. Damage was extensive and very dangerous to people in the spaces below. Fortunately, the earthquake occurred when most offices were not occupied. Forces in this location were 0.2gV and 0.25gH.*

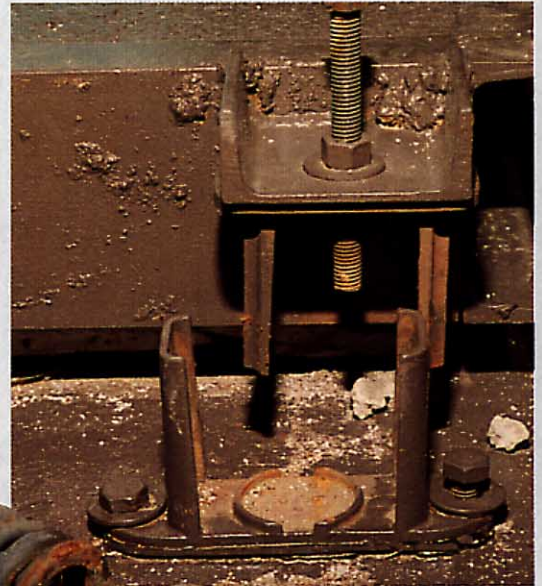
*This is a common but unacceptable method of mounting an emergency generator. The generator was bolted to a concrete floating base and supported on springs within gray iron castings. As in other applications, these castings failed to restrain the generator because both the corner rubber inserts and the springs flew out. This design has no upward restraint either. Of all the equipment, every precaution should be taken so the emergency generator remains operational. Failure was total at the very low levels of 0.1gV and 0.15gH. The steel framed reinforced concrete base looks satisfactory, but the supports should have been spring mountings protected by proper snubbers or springs within all directional ductile housings.*
