A PICTORIAL STUDY OF

# SEISMIC DAMAGE

AND THE USE OF  
PROPER SAFEGUARDS.

SD-100

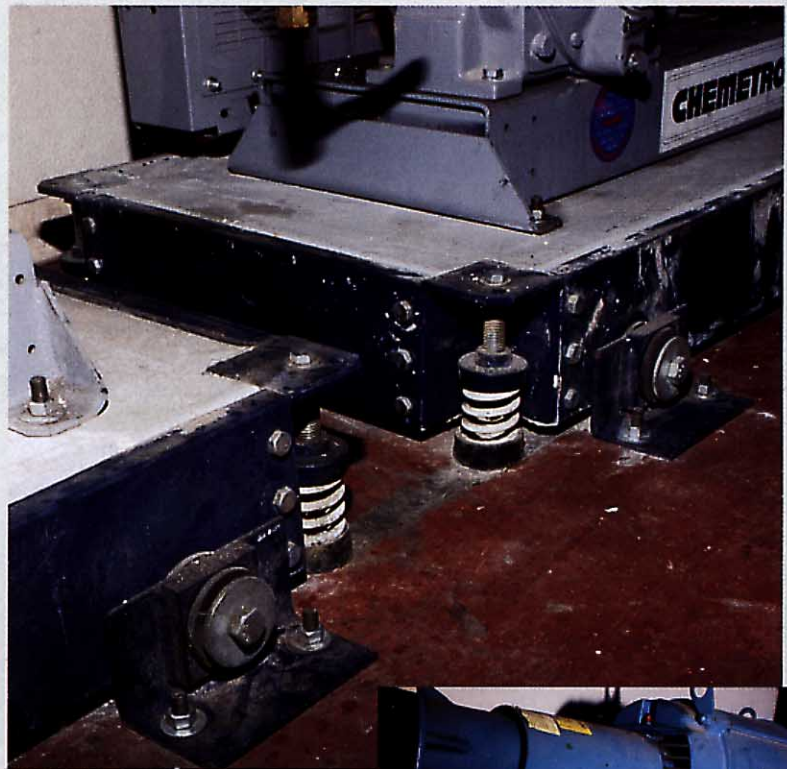
*This pump system is mounted on a steel frame to minimize floor loading. The springs are inside a steel seismic housing with all directional elastomeric grommets to prevent hard surface impact. Anchor bolt edge distance was more than adequate and the system showed no sign of failure. (Mason MSL Base, SLRA Spring Mountings with extended base plates)*

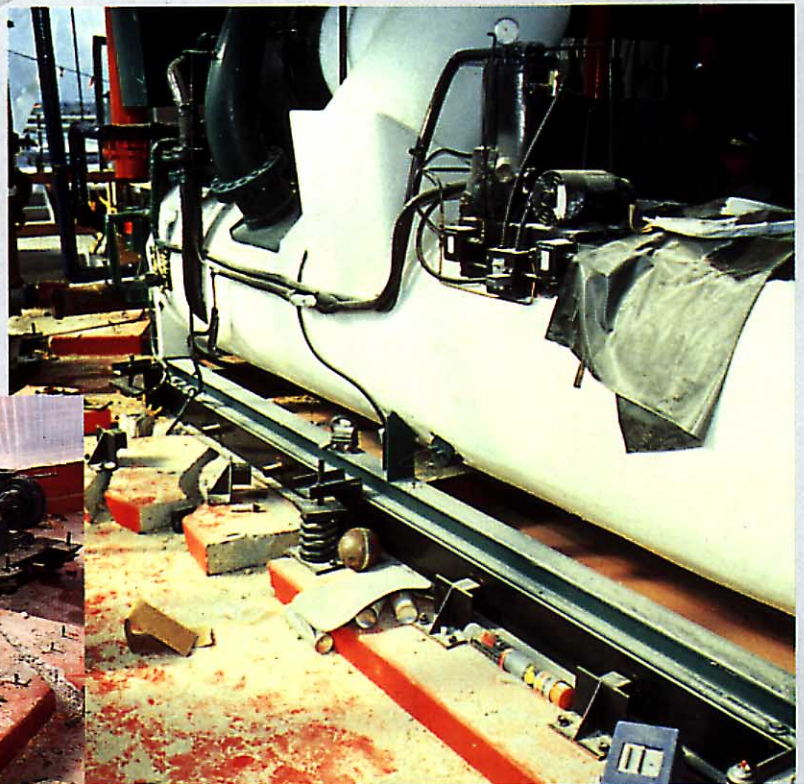
Housekeeping pad failures were common, because of improper doweling or fastening to the structural floor, and inadequate or no reinforcement in the pad itself. These pads, as the pads on the cover, had both problems. Inadequate fastening allows the pads to lift, chatter and shift. Poor reinforcement allows breakage. When the pads fail, the system must fail as nothing remains in place.

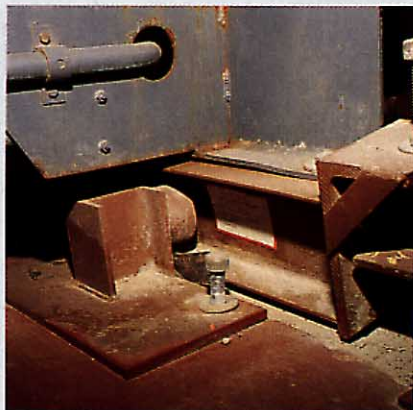
The anchor bolts were too close to the edge of the concrete housekeeping pad for the concrete to offer adequate resistance to the horizontal anchor bolt forces. The edges broke off so the anchor bolts were freed. This total failure of the restraint system occurred at only 0.15gV and 0.15gH. The mountings themselves showed considerable distortion as well.

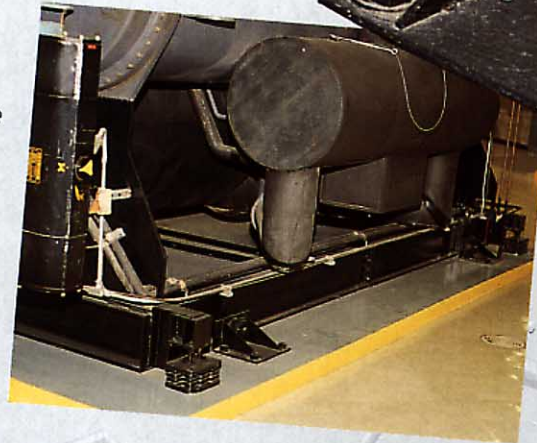
Chiller systems need not fail. The wide flange structural frame was supported by spring mounts under height saving brackets. Springs were not bolted down since the all directional seismic snubbers prevent excessive movement and spring failure. The maximum force was 0.3gV and 0.4gH.

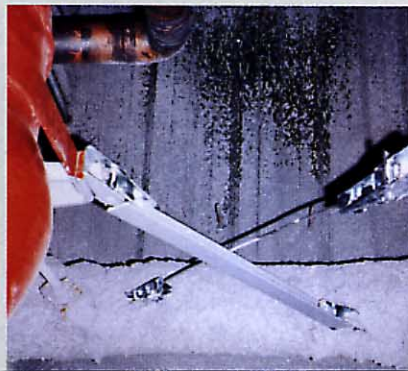
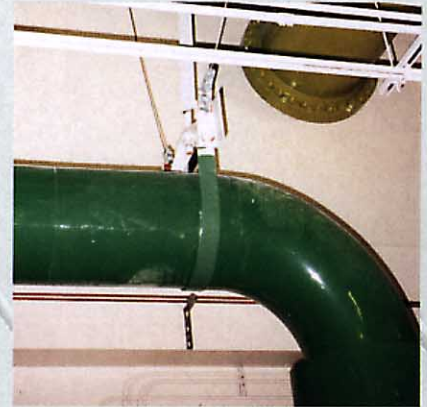
An unusual photograph showing both solid and cable braces. Both systems use swivel fittings specifically designed for the purpose to simplify installation and provide OSHPD approved attachment. Contractors often prefer cable to solid bracing even on non-isolated piping, because cables can be installed more quickly. (Cable Braces Mason Type SCB, Solid Braces Mason Type SSB)

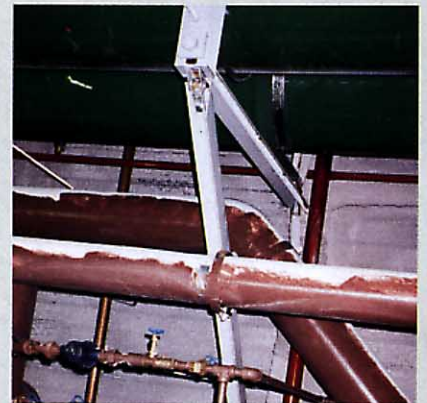
The swivel sway brace fittings at the ends of the angle iron brace eliminate welding, fitting and fabrication time. Solid sway braces can only be used on equipment that is not isolated. When equipment is isolated, bracing must be by cable or isolated devices to prevent transmission of vibration. (Mason SSB)

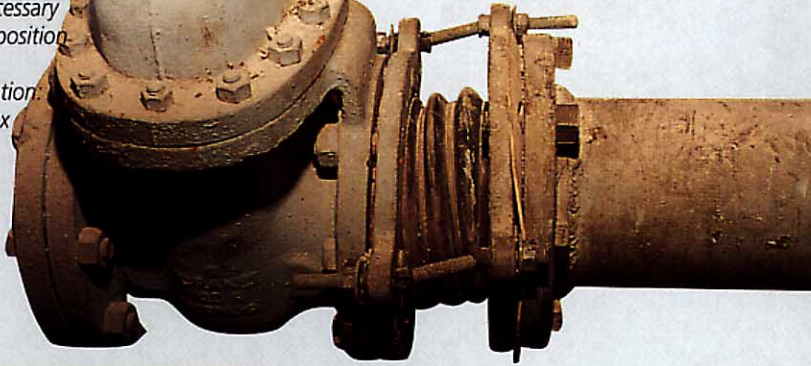
Metal flexible hose is designed to accept motion at right angles to the axis. The hoses prevented pump body failures, but after the system was back on line, the hoses leaked. Leakage was caused by metal fatigue, over travel transverse to the axis or compression and extension. Double sphere rubber connectors are all directional and can respond to motion in any direction without failure. (Recommendation: Mason Safelex SFDEI)

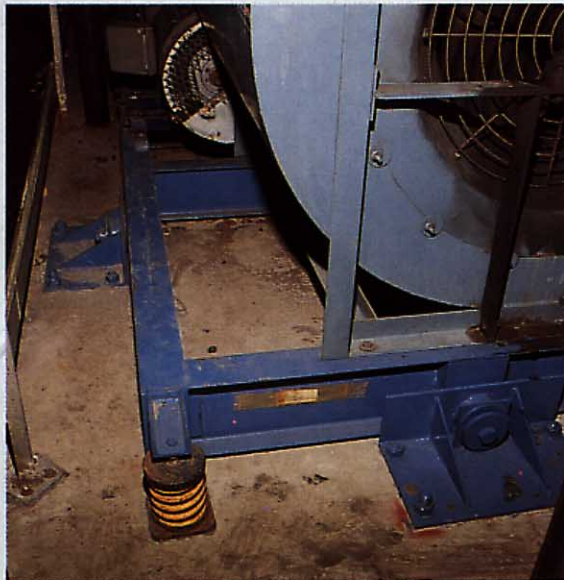
*One of the proper ways to mount a fan and motor is to bolt the equipment to a rigid rectangular steel base. The spring mountings friction pads eliminate the need for bolting as the snubbers will limit motion. All directional thick Neoprene snubber bushings both restrain and cushion shock. (Mason WF Base, SLF Springs, Z-1225 Snubbers)*

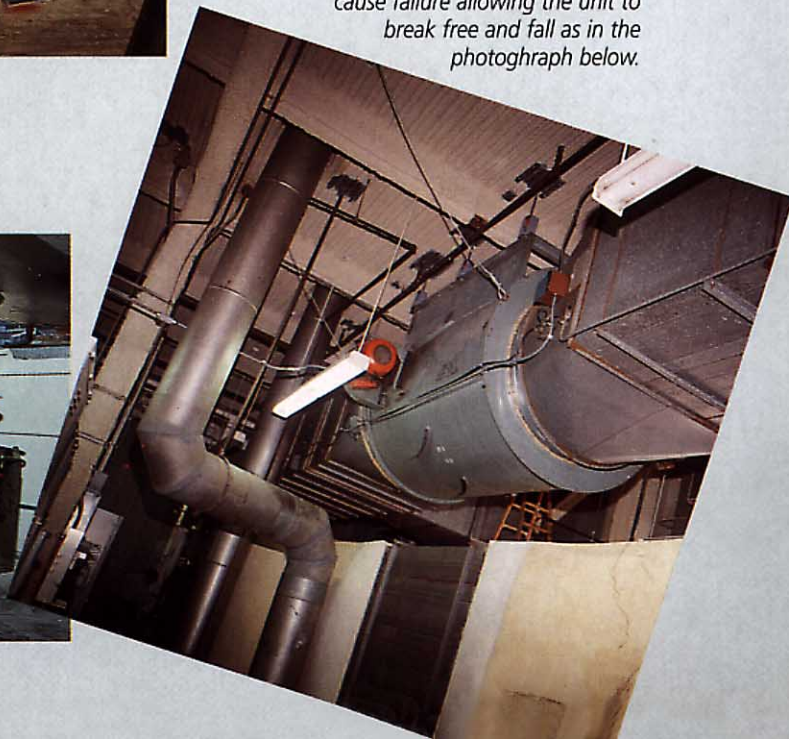
*This small tubular fan broke free of the ceiling and landed on the mechanical room floor. It could have caused severe injury or equipment damage. Electrical lines and control panels are particularly sensitive. This swinging almost always takes place when seismic energy is applied to suspended systems. Proper cable sway bracing would have limited the pendulum action.*

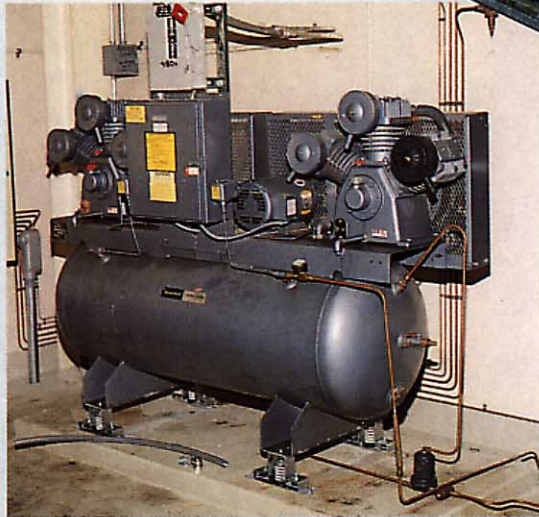
*This is a simple isolation method for a horizontal tank mounted compressor (if the base legs are sturdy enough) without the use of a supplementary steel base. Mountings have built in seismic snubbers with ratings from OSHPD in the State of California. Not only these mountings, but similar designs were successful in every reviewed location. Forces were approximately 0.2gV and 9.25gH. (Mason SLRA Mountings)*

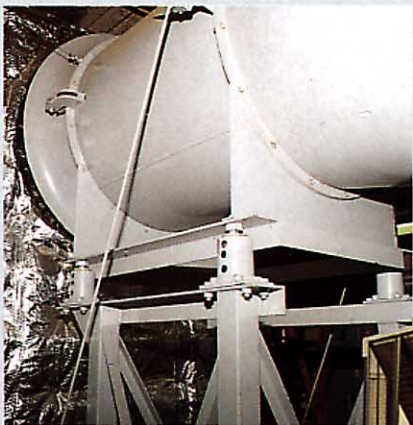
This excellent design uses square steel tubing as the support columns, cross braced by steel angles. The frame was securely fastened to the structure and the isolation positioned on top. Self-contained ductile iron, seismic mountings supported a supplementary steel base under the blower. The system was subjected to very high forces of 1.4gV and 1.2gH with no failure to the system. (Mason Industries' MS Lower Base, SSLFH Ductile Iron Seismic Mountings, MSL Steel Base)

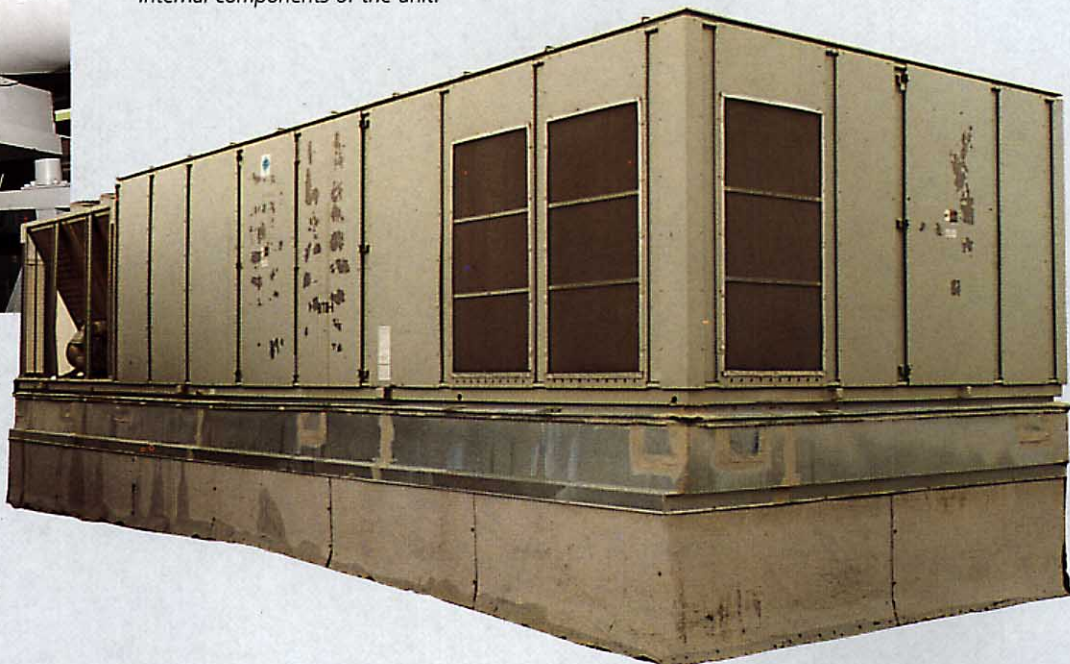
This properly designed seismically rated spring curb had resistances based on testing to allow for seismic input. The input forces were approximately 0.2gV and 0.25gH. The spring curb prevented damage to the lower support curb and the internal components of the unit.

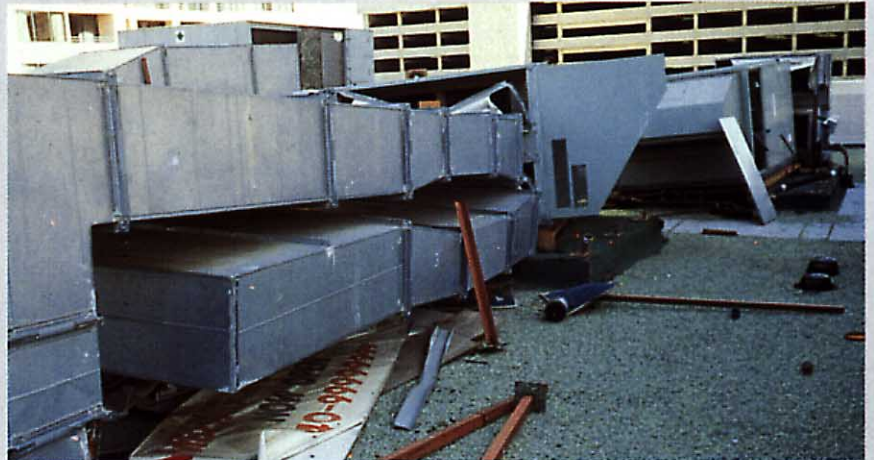
The roof mounted ducts were supported by the steel columns. The four columns were not interconnected, because the loading was so light. However, horizontal forces were large enough to cause failure as the supports were not cross braced to form one integral unit.

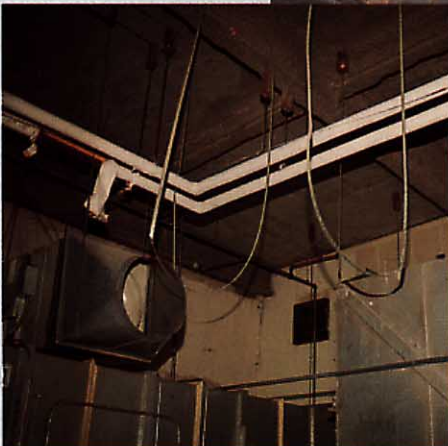
Duct work is very susceptible to seismic damage. Notice the straps that held the ducting that is now on the floor shown in Photograph to the left. This can be prevented by the use of sway bracing to limit sway and keep the duct work in place. Input was 0.15gV and 0.2gH.

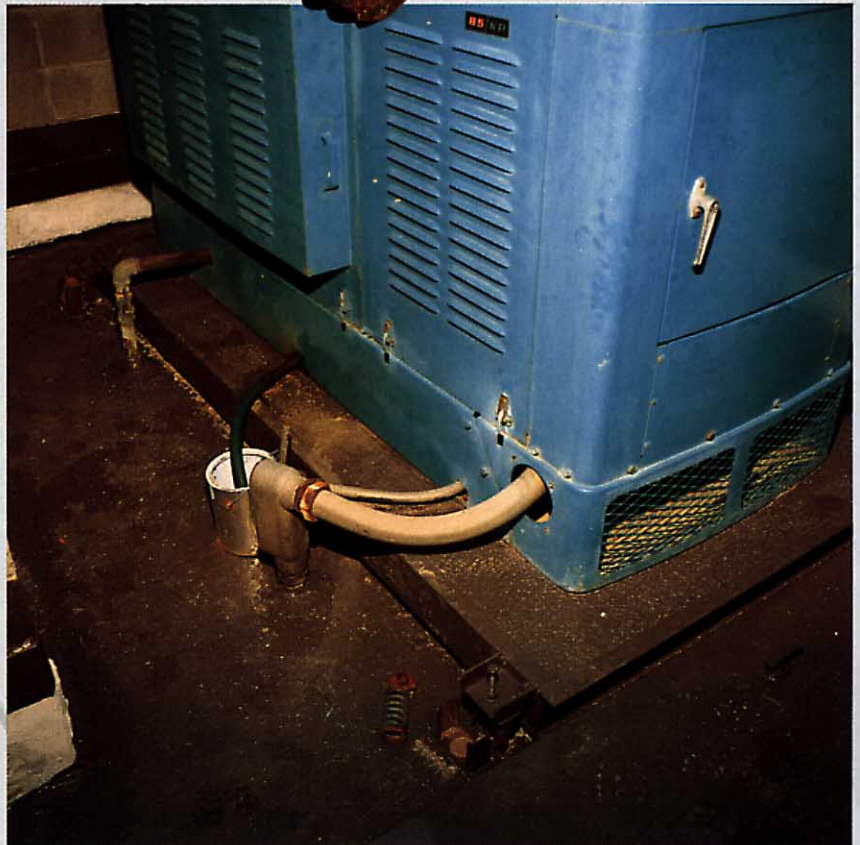
*This is a common but unacceptable method of mounting an emergency generator. The generator was bolted to a concrete floating base and supported on springs within gray iron castings. As in other applications, these castings failed to restrain the generator because both the corner rubber inserts and the springs flew out. This design has no upward restraint either. Of all the equipment, every precaution should be taken so the emergency generator remains operational. Failure was total at the very low levels of 0.1gV and 0.15gH. The steel framed reinforced concrete base looks satisfactory, but the supports should have been spring mountings protected by proper snubbers or springs within all directional ductile housings.*
